The *Alexander L. Kieftand* Accident

Proceedings from
The First Robert Bruce Wallace Lecture
Department of Ocean Engineering
Massachusetts Institute of Technology

Lecturer
Professor Torgeir Moan
The Norwegian Institute of Technology
Trondheim

28 April 1981

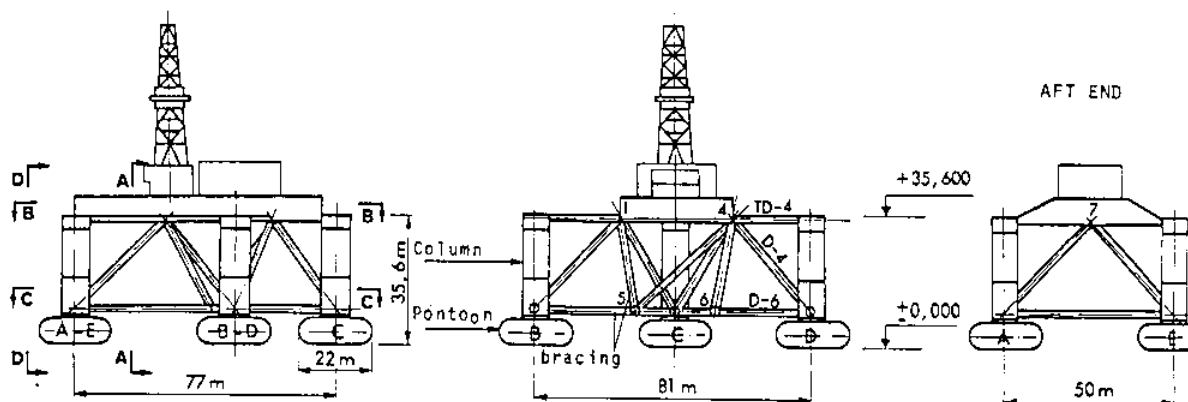
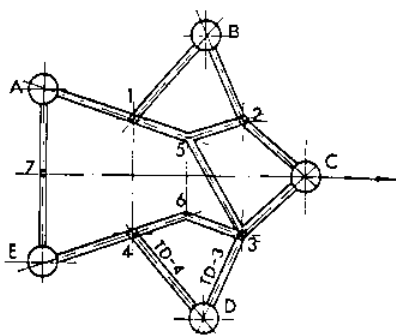
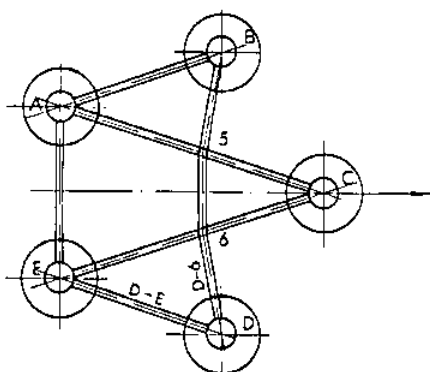
Figure 2
General layout of the
Alexander L. Klelland.

The *Alexander L. Klelland* is a mobile platform of the pentagone type developed in France in 1965-70. As shown in Figure 2, the platform consisted of five pontoons (columns) which made up the major buoyancy elements. The columns and the deck on the top were supported by bracings. Figure 3a shows the starboard side of the platform with the location of the hydrophone, a positioning instrument, on bracing D-6. The hydrophone support was fixed to the bracing by inner and outer fillet welds, as shown in Figure 3b. The platform was constructed in France after a contract was signed at the end of 1973 by a French yard and the Norwegian owners. Figure 4 shows the platform under assembly. The *Alexander L. Klelland*, the ninth of the pentagone designs to be fabricated, was delivered to the owners on July 5, 1976.

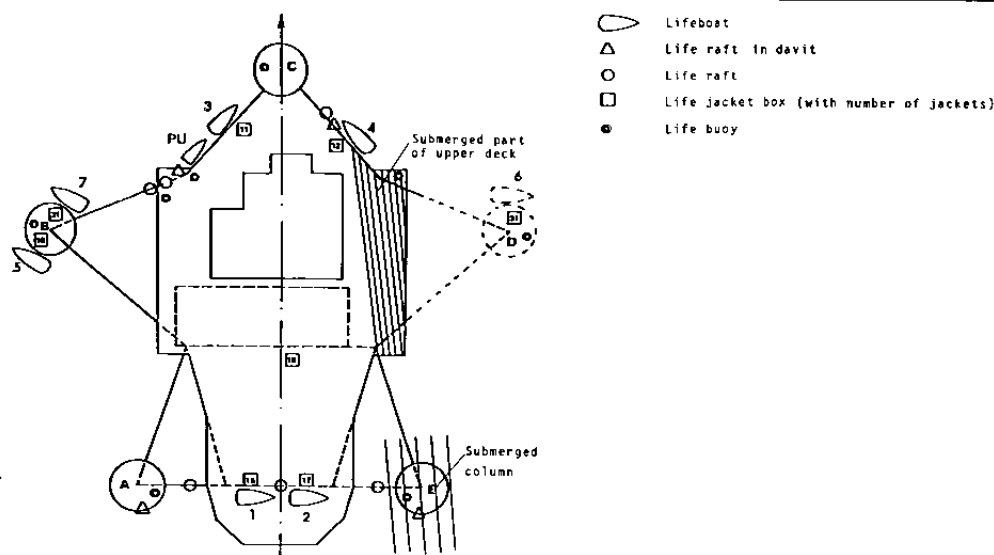
Figure 14
Lifesaving appliances
on board the *Alexander*
L. Kielland.

The *Alexander L. Kielland* was equipped with lifesaving appliances as required by regulations. See Figure 14. Rescue training on board was generally carried out in accordance with regulations; however, too much emphasis had been put on lifeboat practice. Only a few men on board had been given the safety training in advance, as required by regulations. Although the crew and the catering personnel on board were required to attend a three-week introductory course on safety practices, theoretical and practical, only four of the persons on board had participated in this kind of instruction. One crew member had taken a shorter, two-week safety course. Concerning the so-called "hotel guests," there are no precise requirements in the regulations regarding their safety training. However, "Arbeidsmiljøloven" (Workers' Environment Law), which applies to employees, except for the mustered personnel, on floating platforms and fixed installations, states that all employees shall be informed about the accident and health risks. This law applied to the *Alexander L. Kielland*. Only a small number of the hotel guests had fulfilled any course and, moreover, these courses lasted essentially for one day. Of the 212 men on board the *Alexander L. Kielland* the day of the accident, only 76 persons had attended any courses. Among these, 50 persons had only been through a one-day course. Studying those who perished and those who survived, it appears that the type of training did not itself improve the chances for surviving the catastrophic circumstances of the accident. Other factors, such as experience at sea, seem to have been more important.

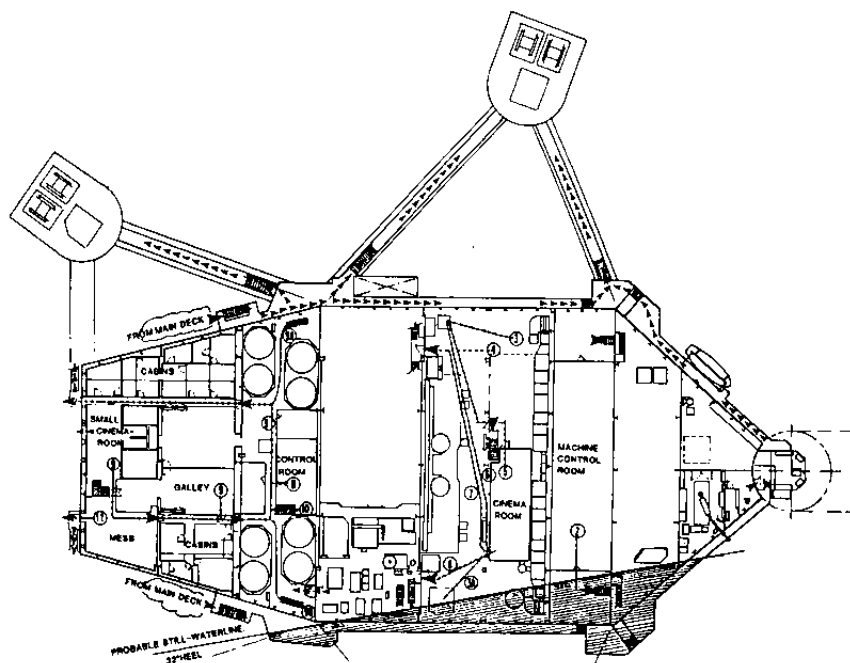
Figure 16
Escape ways on the
intermediate deck.

When the accident occurred, most people on board were on the intermediate deck. See Figure 16. About 60 were in the mess at the aft end of the platform, and 30 were in the cinema room, adjacent to the mess. About 60 men sat in the temporary cinema room amidships. Roughly 30 were in their cabins, while the rest, about 30 men, were in various places all over the rig.

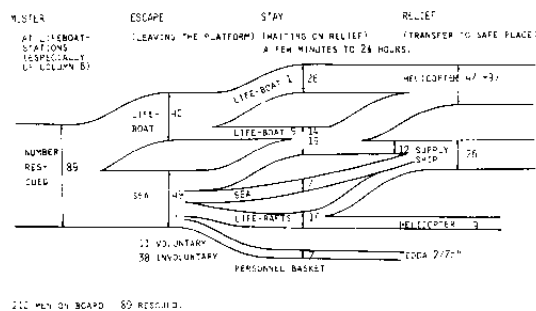
Figure 20
Summary of the evacuation and rescue operation.

In regard to the two lifeboats which were successfully launched, 26 men on board the first were rescued by helicopter a few hours after the accident. The other boat held 14 persons when it first entered the seas. After that, 19 persons were pulled into the boat from the water. Of these, 12 men were later taken on board a supply ship, while the other 21 were rescued by helicopters. Those who were on board the lifeboats claimed they were severely chilled.

On board the *Alexander L. Kielland* there were inflatable rubber rafts with a total capacity to hold 400 men. The rafts were designed to be lowered by crane or thrown overboard. Unsuccessful attempts were made to release some of them. Some, however, were released as a result of the platform list. The inflatable systems on some rafts were activated when they hit the water; three men managed to board. These men were later rescued by supply vessels. Inflatable rafts were also thrown overboard from Edda 2/7C. The nine men who managed to board these were hoisted aboard a British rescue helicopter. Four men were rescued by a supply vessel from another raft from Edda 2/7C.

Figure 20 summarizes the way the survivors evacuated the platform and were rescued.
